INDOOR AIR QUALITY ASSESSMENT

**Malden Fire Department, Maplewood Station
665 Salem Street
Malden, Massachusetts 02148**

Prepared by:
Massachusetts Department of Public Health
Center for Environmental Health
Emergency Response/Indoor Air Quality Program
January 2006

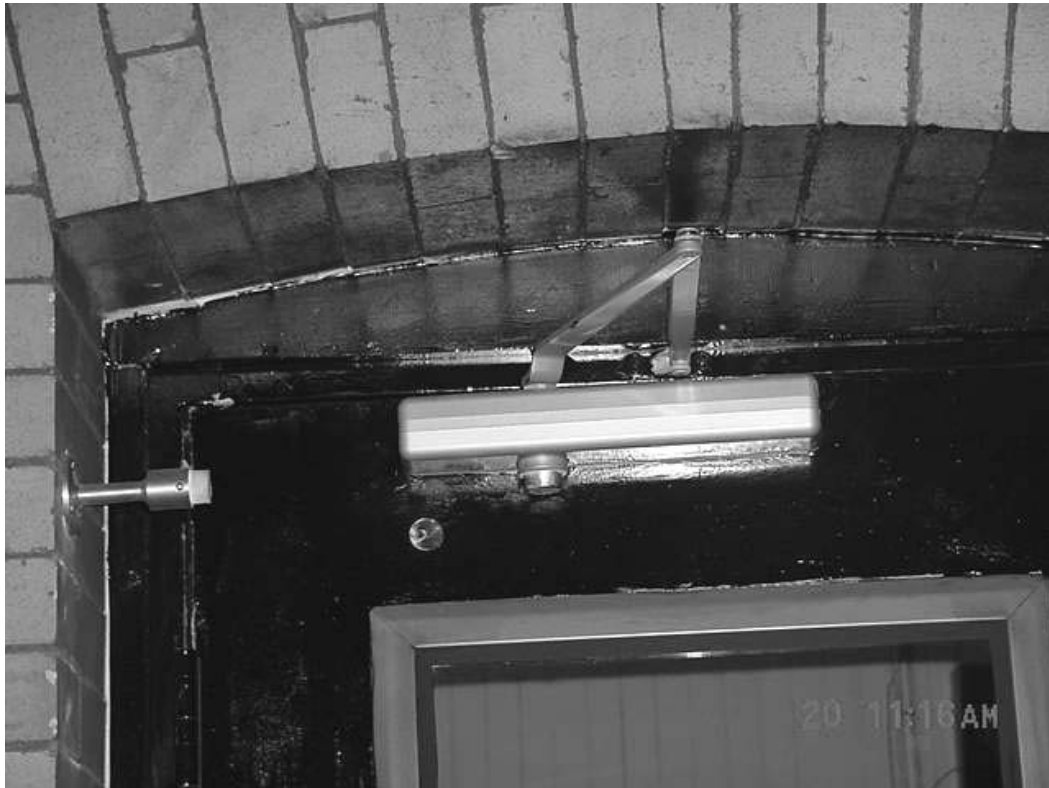
Picture 31

Automatic Door Closure Hardware

2. Install handle on the interior side of patrol room door (Picture 30).
3. Install automatic closure hardware on stairwell doors (Picture 31).
4. Consider removing fire pole and sealing access hole. If not removed, install clamshell-type closures around firepole to prevent pollutant pathways.
